The following entries in this ledger are made in accordance with paragraph 3.2 of Service Test Procedures of the [REDACTED] Model HJA/5 Photographic Film Processor dtd 5 July 1963 Prepared by Target Materials Division, Directorate of Intelligence Hq SAC.

Monday 30 Sep 1963:
Entry #1 ~~Tuesday 1 Oct 1963: Fd~~

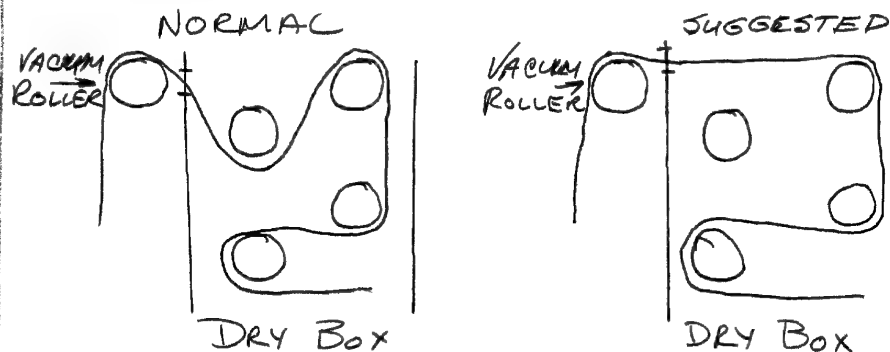
This permits the film to leave the vacuum roller at about 45° or approx. 3" sooner. As follows:

Several hundred feet of film was processed in this method without any trouble. This also eliminated the indentation marks made by the vacuum holes in the roller. Several screw came loose in the torque take up and had to be operated by hand until the lights were turned on and the unit could be fix^{ed}.
 - Record of night's run:
